# Americans with Disabilities Act Transition Plan: Public Facilities and Pedestrian Right-of-Way

Wabash County, Indiana

Adopted: February 3, 2014

*November 22, 2021*

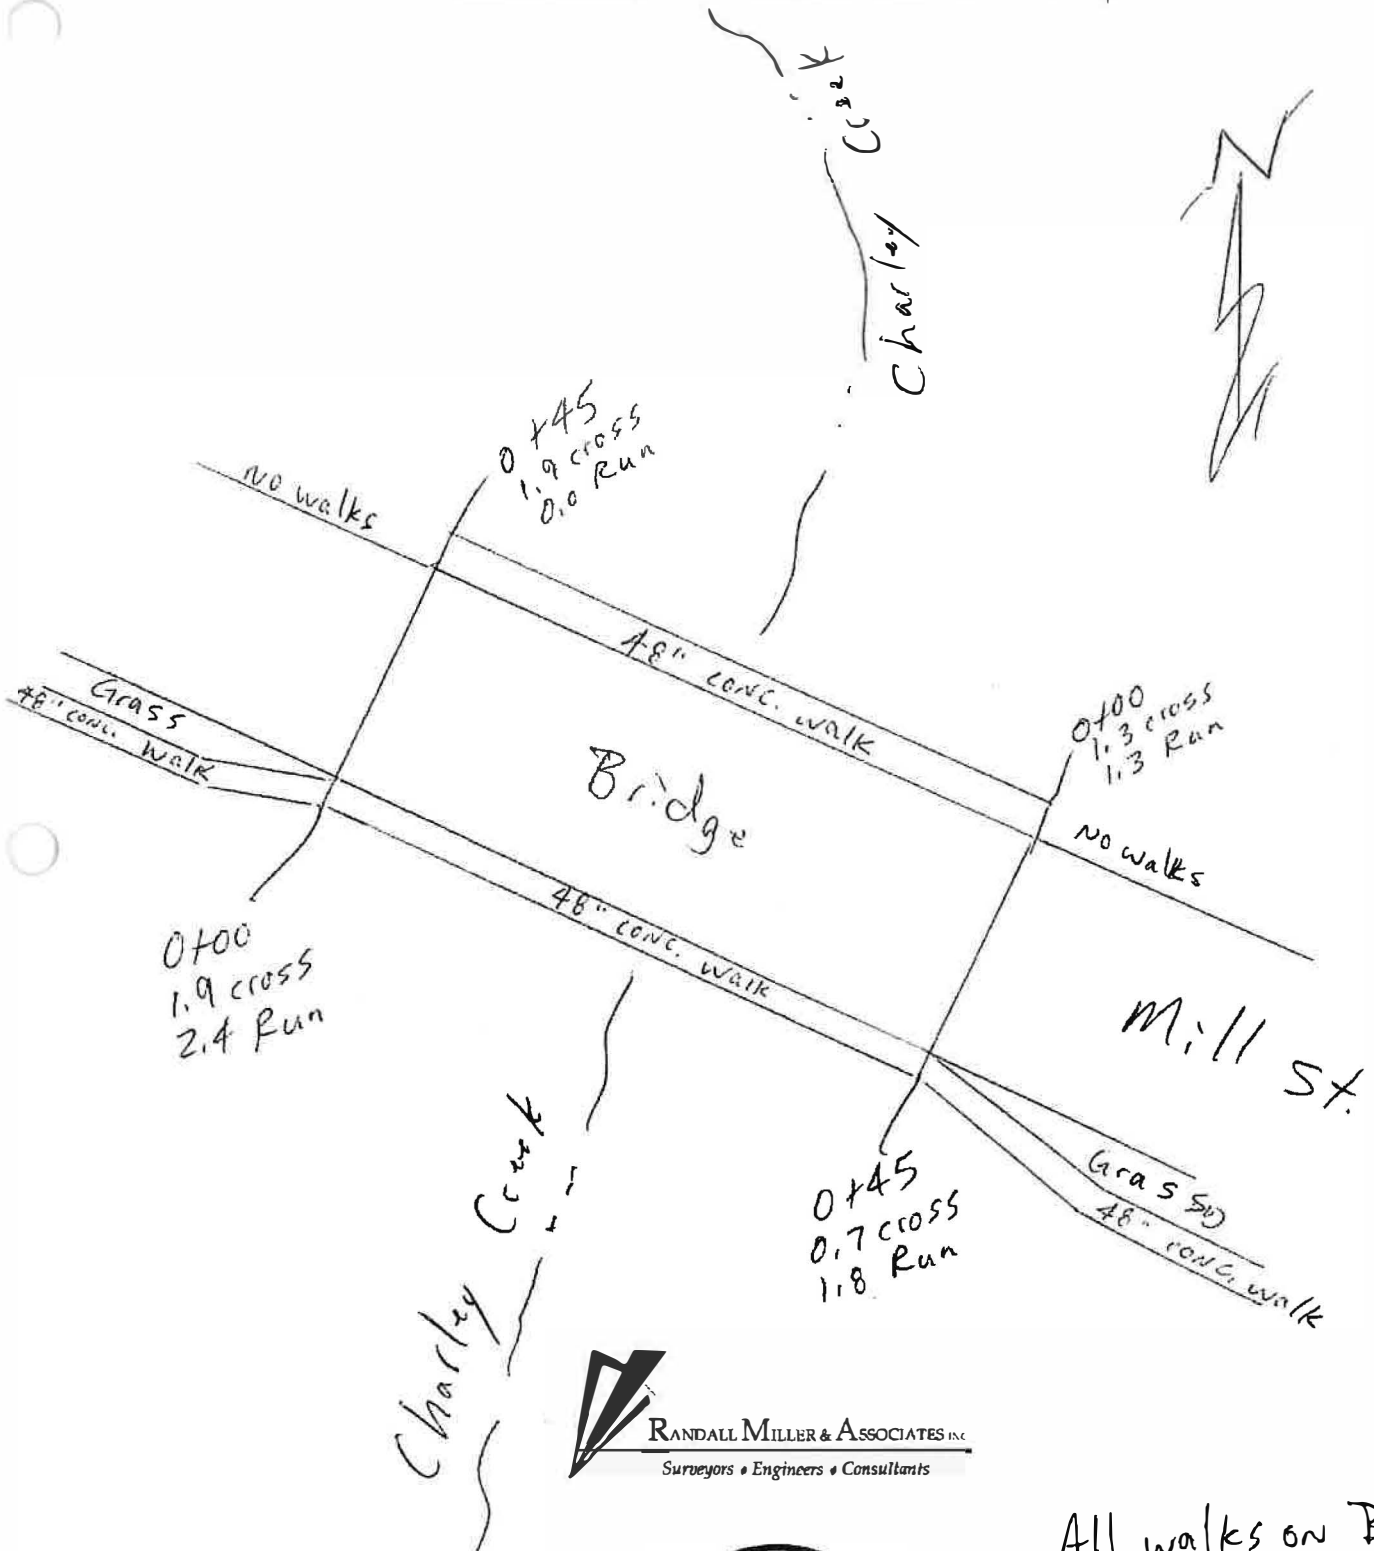
LPA: Wabash Co. Location: Mill St. Bridge#: 504 Crew: BC/SF Date: 8-12-13 ID: \_\_\_\_\_

All walks on Bridge  
are in good  
condition

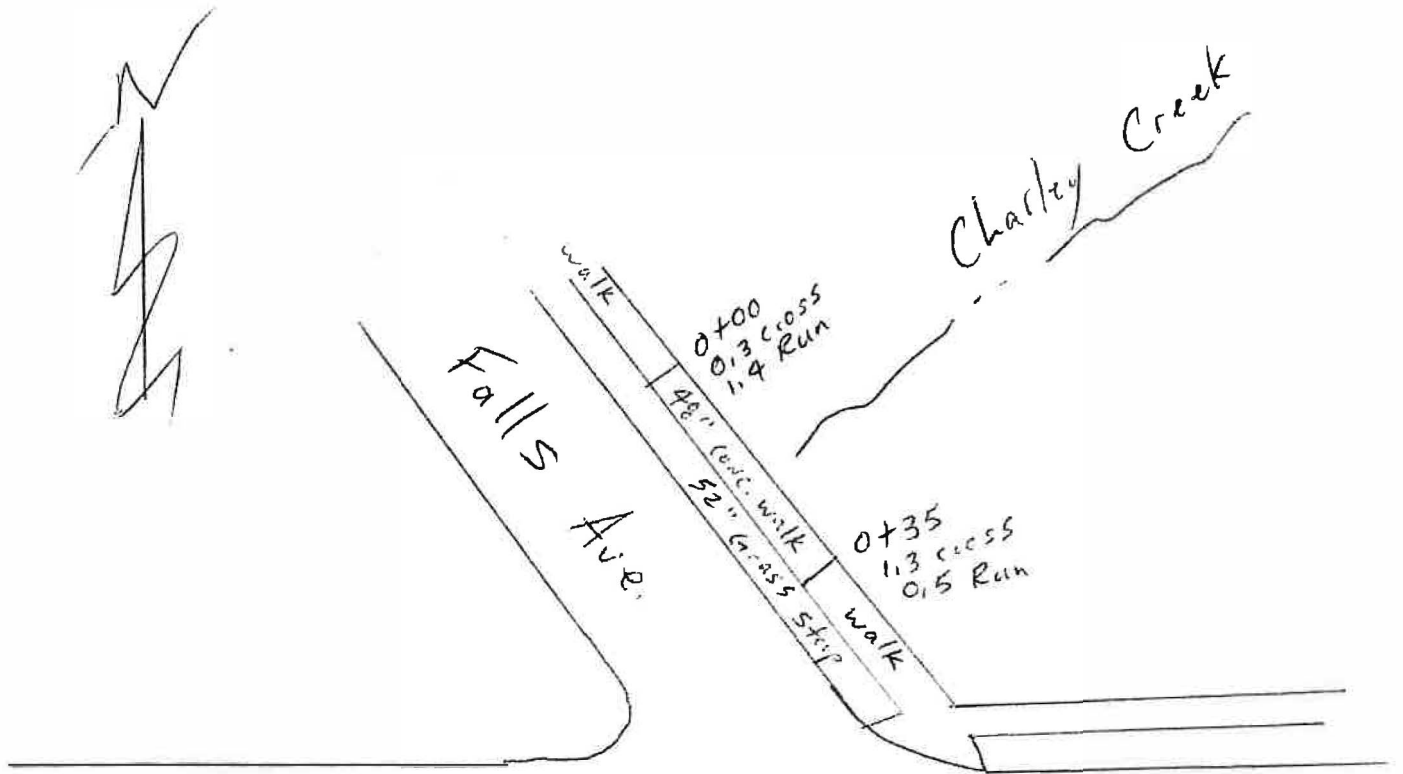
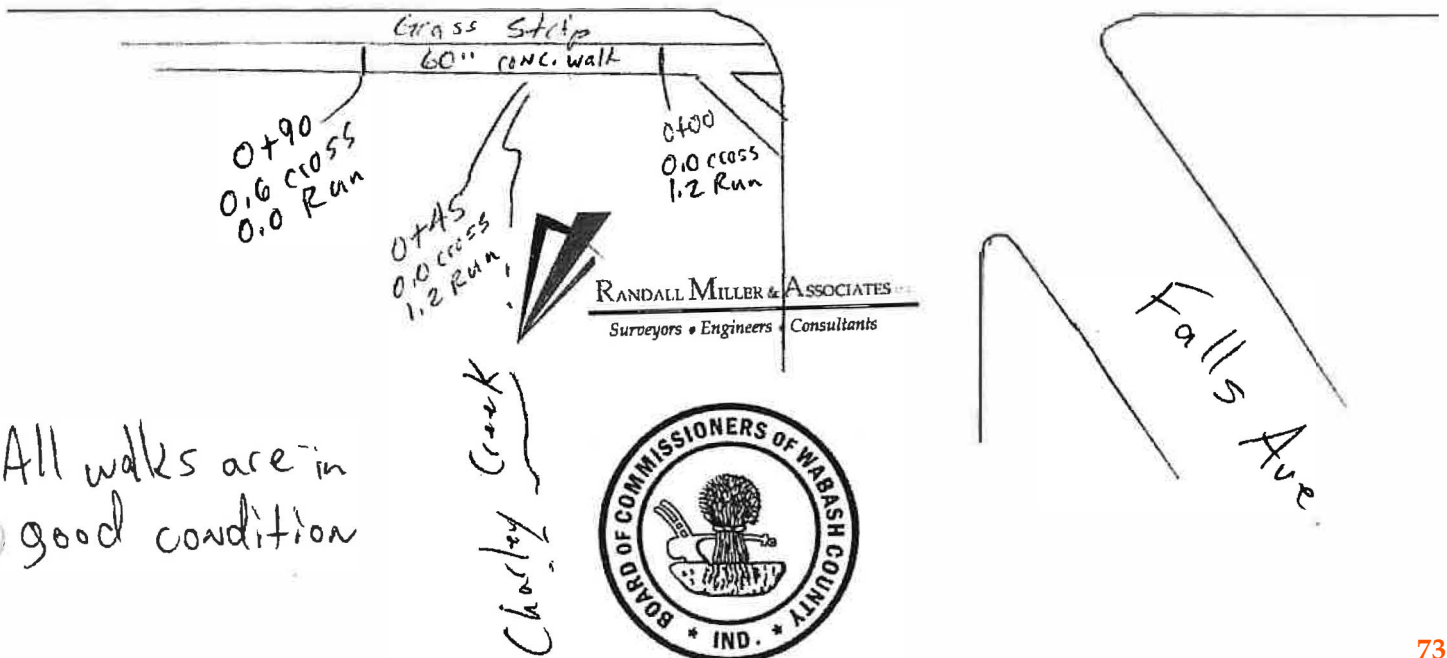
LPA: Wabash Co. Location: Falls & Still St Bridge#: \_\_\_\_\_ Crew: RC/SF Date: 8-12-13 ID: \_\_\_\_\_

All walks are in good condition

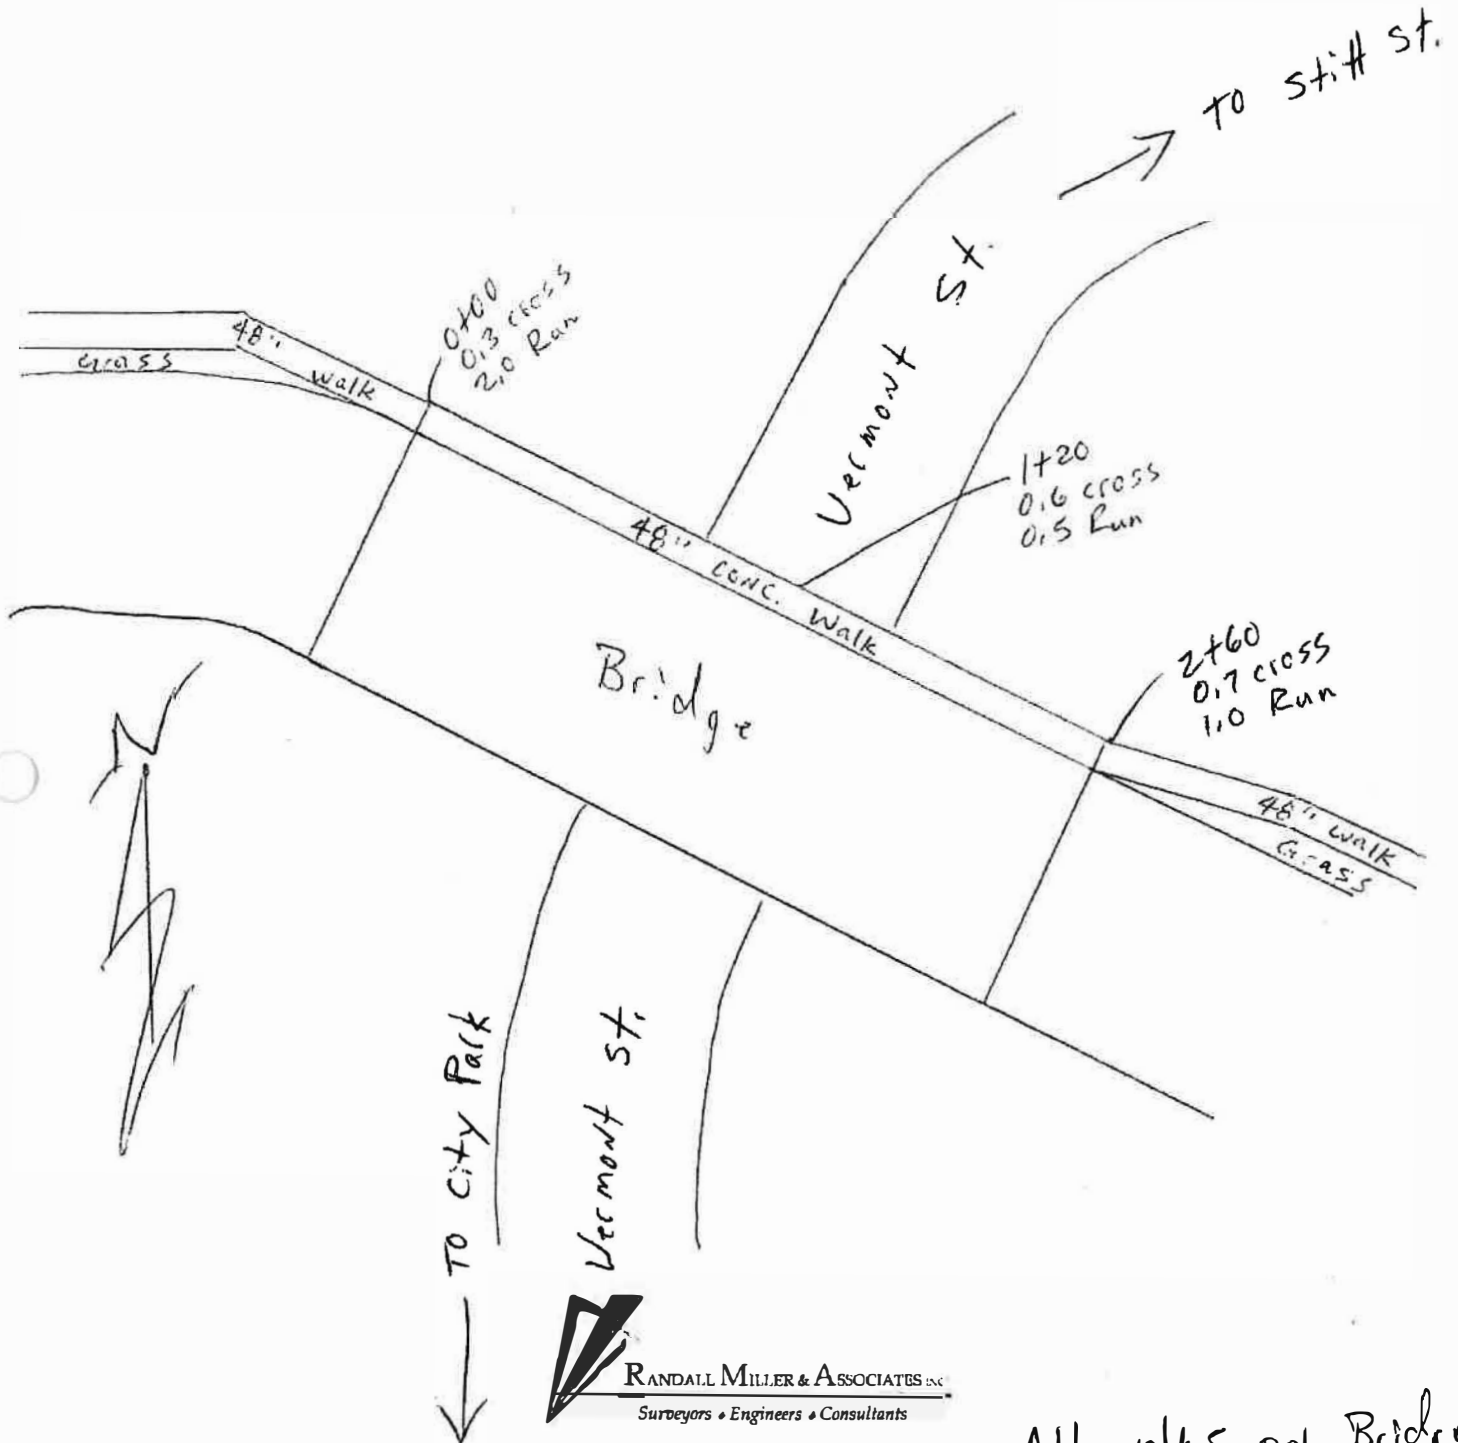
LPA: Wabash Co. Location: Ferry St. Bridge#: 505 Crew: BC/SF Date: 8-12-13 ID: \_\_\_\_\_

All walks on Bridge  
In very good  
condition

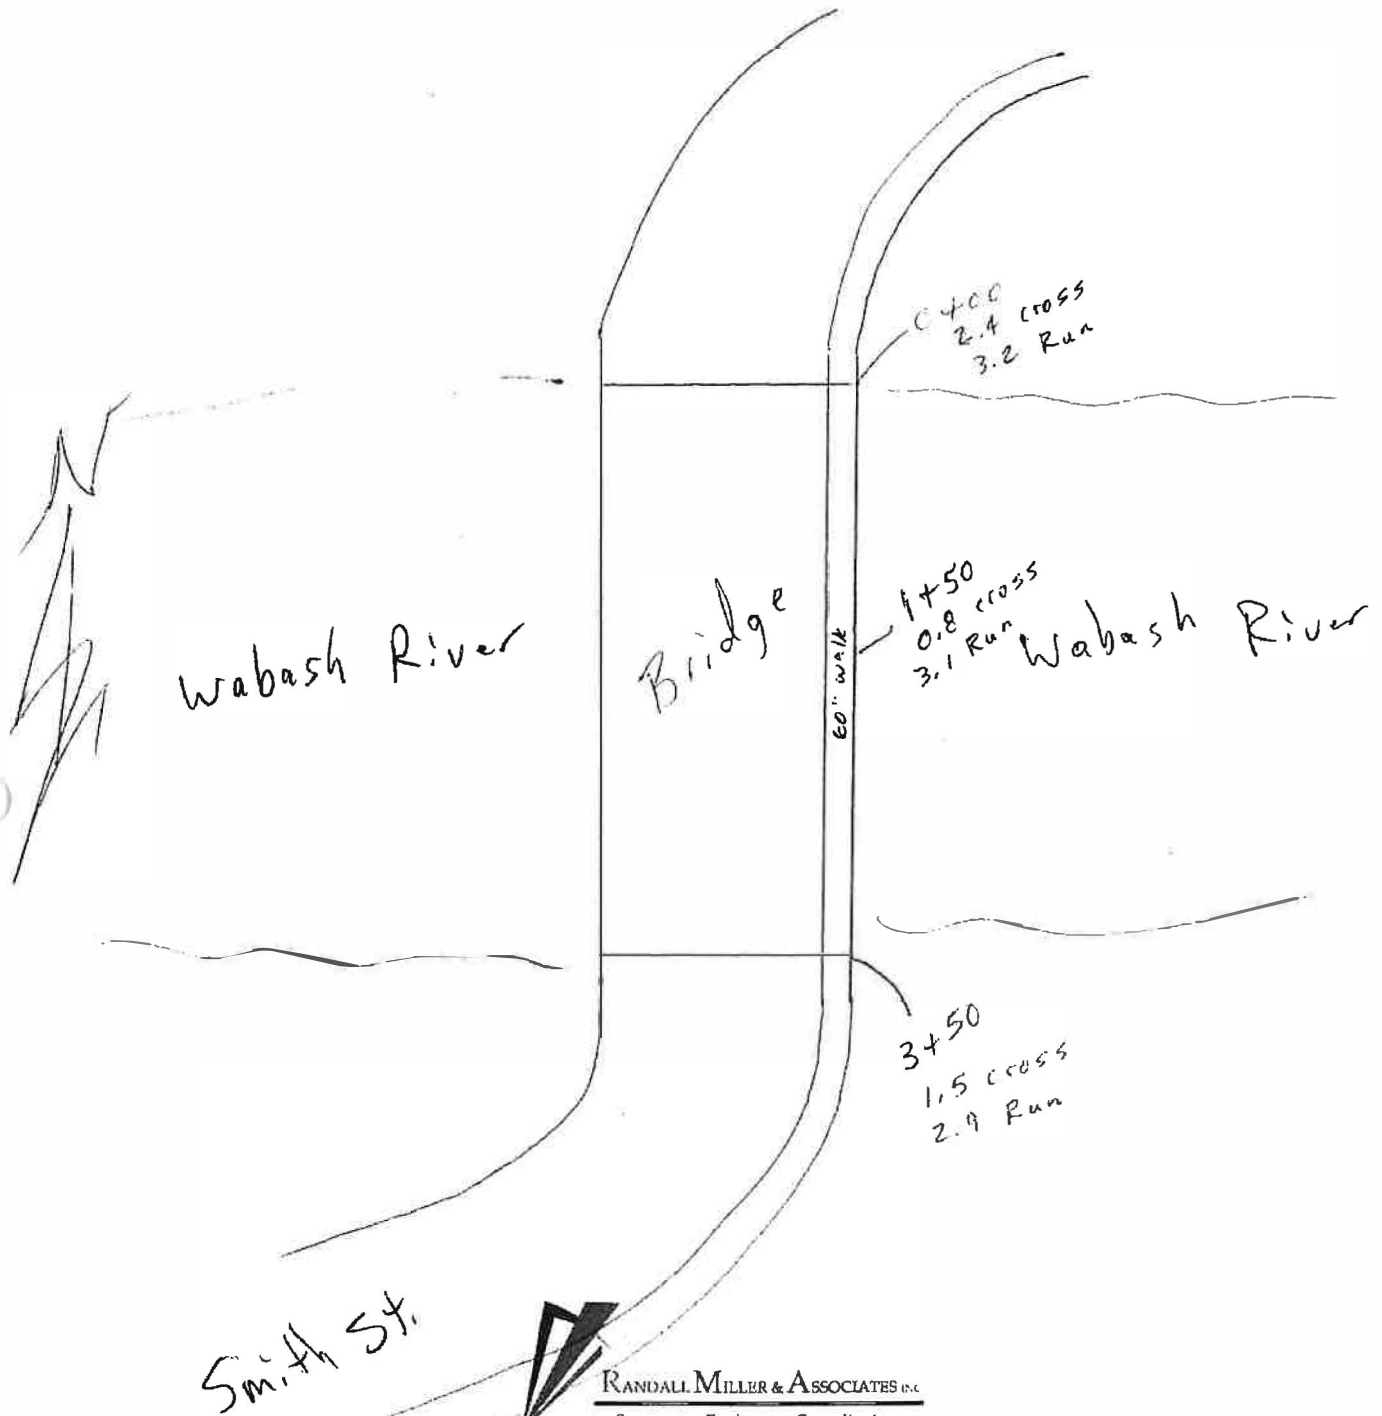
LPA: Wabash Co. Location: Smith St Bridge#: Crew: P.C./S.F. Date: 8-12-13 ID:

Walks on Bridge  
are in good condition  
No protrusions, minor  
spalling in one area.

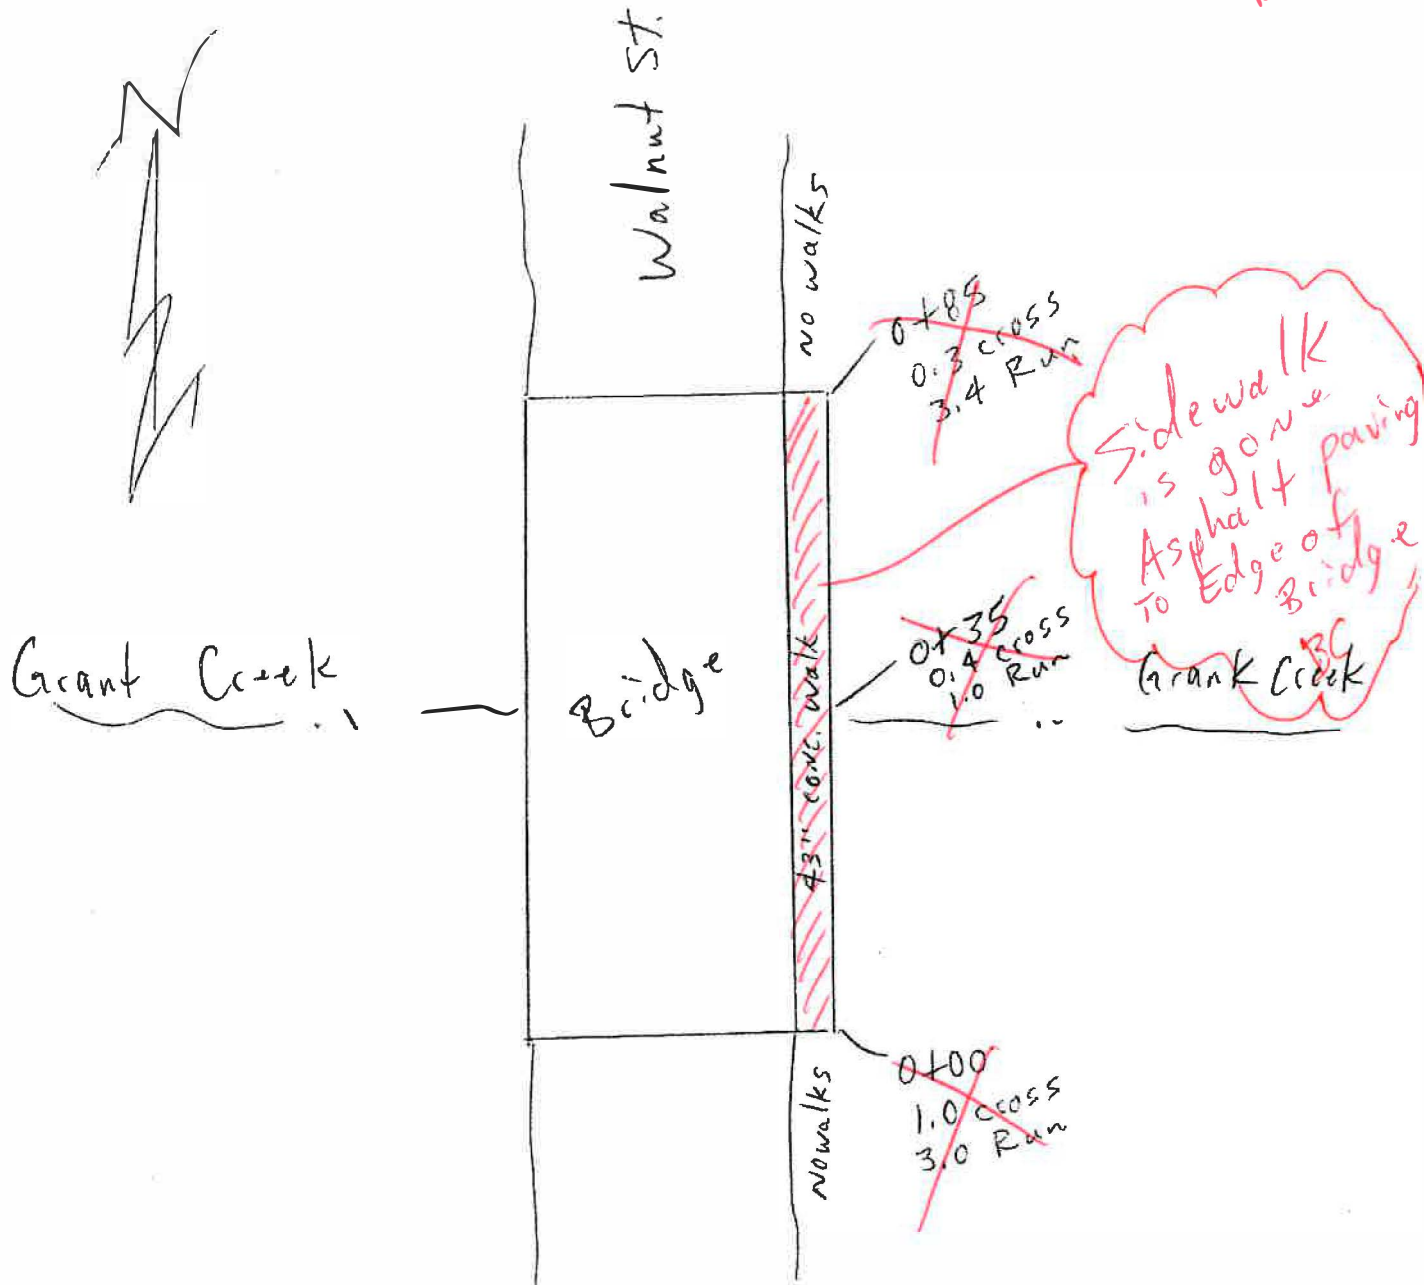
LPA: Wabash Co. Location: Walnut St. Bridge#: 701 Crew: BC/SF Date: 8-12-13 ID: 10-19-21 BC

All walks on Bridge  
In good condition

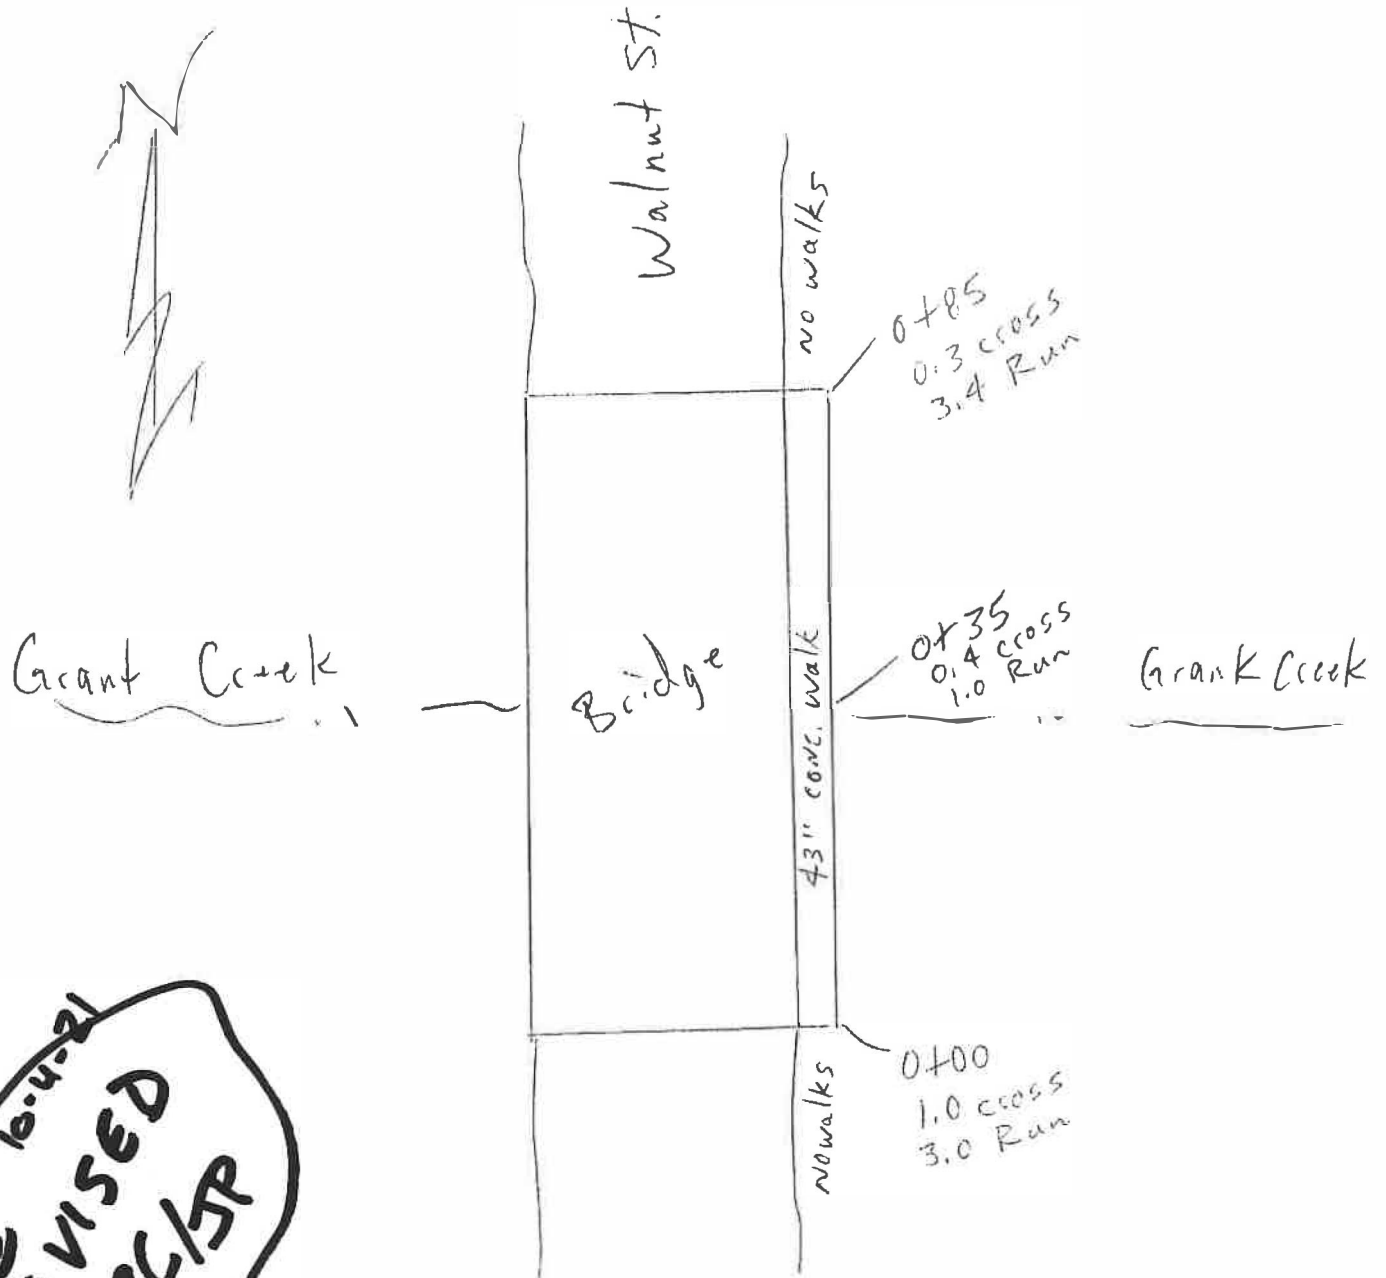
LPA: Wabash Co. Location: Walnut St. Bridge#: \_\_\_\_\_ Crew: BC/SP Date: 8-12-13 ID: \_\_\_\_\_

SEE 10-4-21  
REVISED  
BC/SP

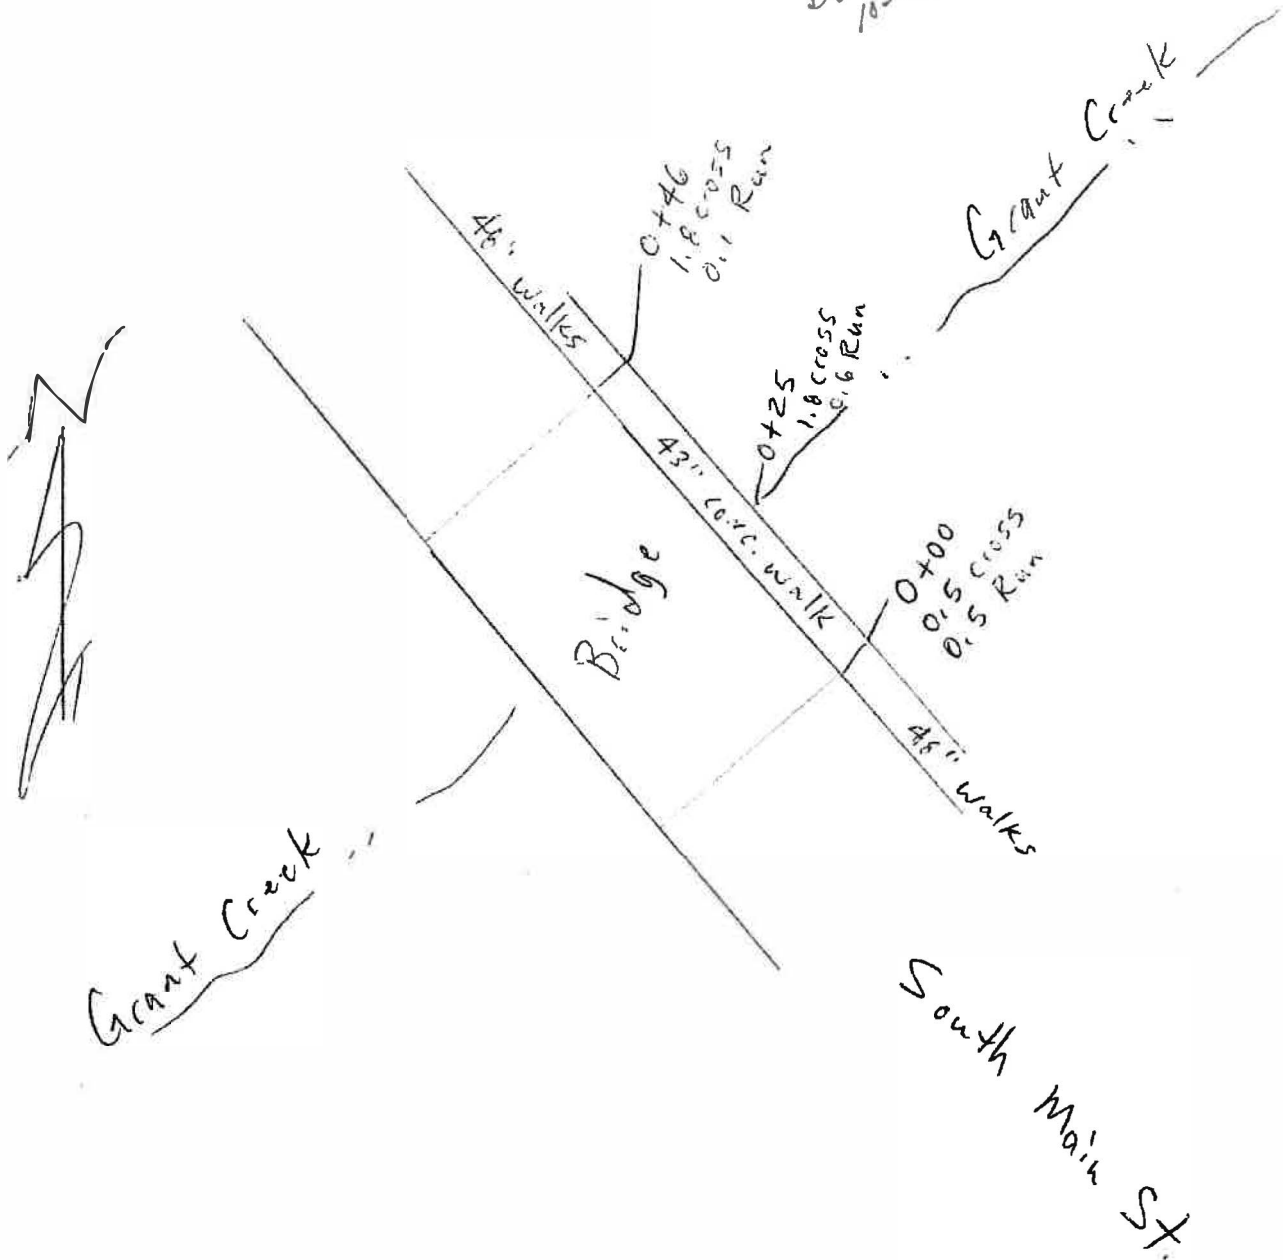
LPA: Wabash Co. Location: South Main St. Bridge#: 702 Crew: BC/SF Date: 8-12-13 ID: \_\_\_\_\_

All walks on Bridge  
are in good condition

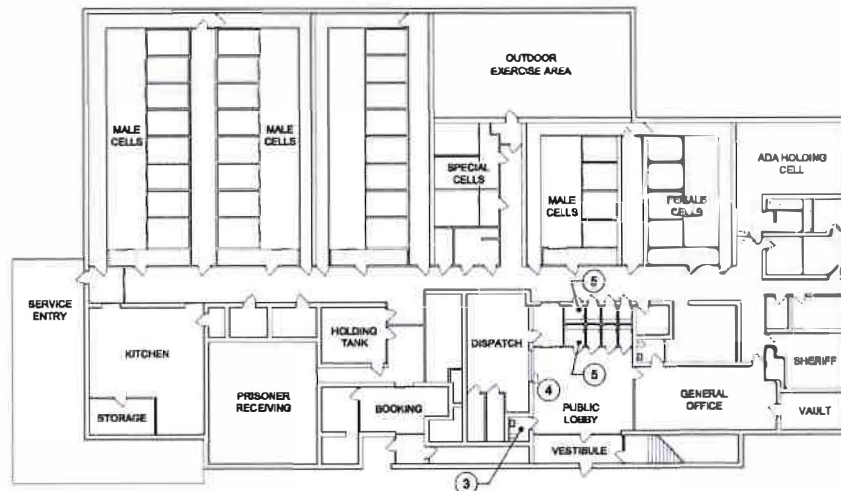
**Improvement Reference Plan**

FIRST FLOOR PLAN  
SCALE: NOT TO SCALE1 x 6 LOCATIONS  
2 x 4 LOCATIONS**ADA Improvement Reference Key**

- 1 Install ADA compliant signage at public locations throughout the building
- 2 Provide new ADA compliant door hardware
- 3 Reconfigure existing toilet room into a single, ADA accessible toilet room - New sink and toilet, finishes, accessories, and grab bars.
- 4 Provide 36" long counter space, 36" a.f.f. max. and min. 27" high x 11" deep clearance below
- 5 reconfigure existing visitation rooms to provide one ADA compliant stall for visitor access and one ADA compliant stall for detainee/inmate access. Provide compliant clearances and counter space (with compliant knee and toe clearance), a 36" wide door and frame, and visitation telephones mounted so operable parts are at 48" a.f.f.

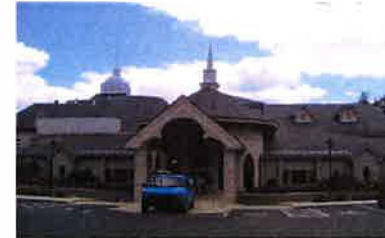
Building: **First United Methodist Church**

**ADA "Access" Deficiencies**1) Run and cross slope in parking lot is non-compliant (~~3.7%~~ 5% max) *Brian Campbell 10-7-21 (BC)*

**Non-Compliant: Issue:**10/7/2021 Items 2 & 3, NO ADA SIGNS FOUND ... *Brian Campbell 10-7-21 (BC)*

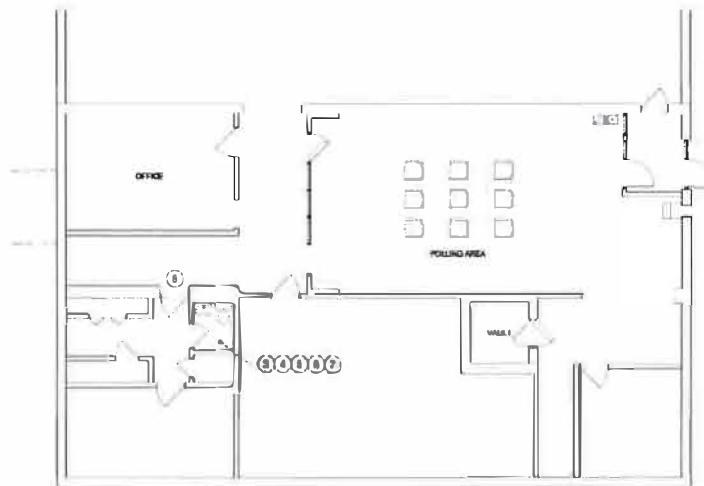
#### Improvement Reference Plan

FIRST FLOOR PLAN  
 SCALE: NOT TO SCALE

- ① x 4 LOCATIONS
- ② x 1 LOCATIONS

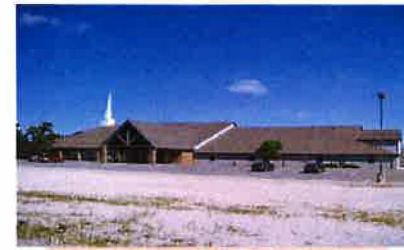
| Improvement Reference Plan | ADA Improvement Reference Key |
|---|---|
| <p>PREP # 2021 PLAN<br/>SCALE 1/8" = 1'-0"</p> <p>1 = 8 LOCATIONS<br/>2 = 4 LOCATIONS</p> | <ol style="list-style-type: none"> <li>1 Install ADA compliant signage at public locations throughout the building</li> <li>2 Provide new ADA compliant door hardware</li> <li>3 Remove existing urinal, cap plumbing, and patch finishes</li> <li>4 Remove existing toilet, cap plumbing, and patch finishes</li> <li>5 Remove/adjust existing toilet partition location to make one ADA compliant stall</li> <li>6 Add all grab bars - side wall (18" vert., 42" horiz.), back wall (36" horiz.)</li> <li>7 Provide ADA compliant sink</li> <li>8 Provide new ADA compliant threshold</li> <li>9 Extend/reduce the slope of ramps to gym</li> </ol> |
